# Safety Glazing

## by Douglas Hansen

(this article last updated October 19, 2011)

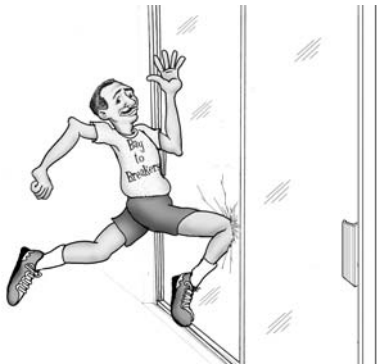
Figure 1 – Impact with patio door

When a person accidentally impacts glass, there are two immediate dangers. The first is from lacerations due to the large shards that might slice into the person. There have been numerous instances of persons who have died from injuries such as a severed femoral artery (*figure 1*). Unless pressure is brought to bear immediately on such a wound, the victim can bleed to death in as little as five minutes. The second danger is from the “rebound” effect. The first reaction to impacting glass is to pull back. By then the glass is broken, and during the rebound, the person is pulling away from the sharp broken edges. The result can be deep lacerations that tear off large flaps of skin along with possible deep tissue damage..

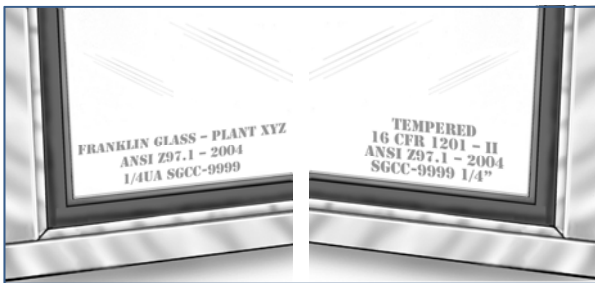
These designations may sound familiar, as they are seen on the identifying “bug” used in tempered glazing today (figure 2).

Figure 2 – Safety glazing labels

An etched label as in figure 2 is required for tempered safety glass, and has been since the first mention of tempered glass in the codes. A full label is required on at least one lite of multiple pane assemblies, and the other lites in the assembly can be marked with only the “16 CFR 1201” designation if they do not exceed one square foot in exposed area. The glass thickness is usually included in the label.

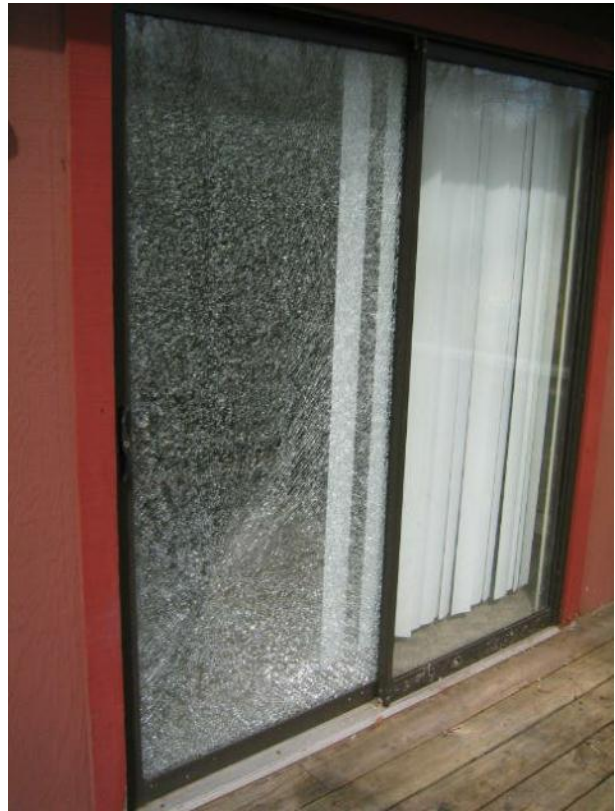
Tempered glass (used in the rest of the car windows) is created during manufacture by rapidly cooling the outer surfaces of a piece of glass while the inner portion, sandwiched between the outer layers, remains viscous. After final cooling, the inner portion of the glass is in tension while the surfaces are in compression. The result is a piece of glass that is four times more resistant to impact than annealed glass. When tempered glass breaks, it fractures perpendicular to the plane of the surface, rather than parallel to it, resulting in harmless small cubes that are less likely to cause significant injury (*figure 3*).

The properties of tempered glass have been known for centuries, though it was not patented as an architectural glazing product until 1900. All glass is vulnerable to breakage from impact at the edges, and tempered glass is even more vulnerable in this regard; scratch the edge with a file and the entire piece might shatter. Because of this characteristic, tempered glass must be cut to size before the tempering process. Tempered glass has characteristic bows and warps due to the tempering process.

Figure 3 – Broken tempered glass patio door

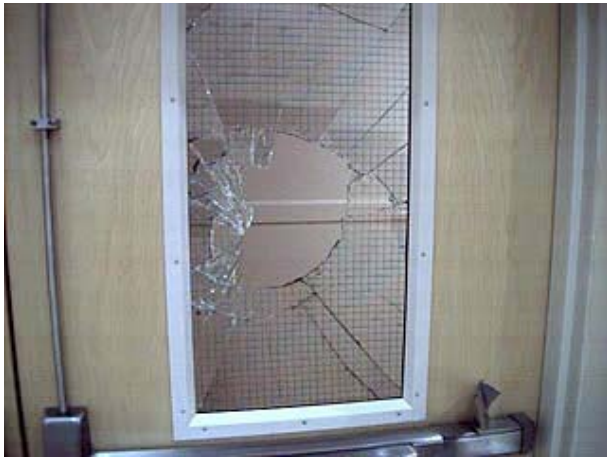
Wired glass is commonly used in “vision panes” of swinging doors to allow someone to see persons on the other side. This violates the original CPSC standard, but was allowed until quite recently; when the choice has been between glass with a fire rating, or glass with a proper safety rating, the fire rating has taken precedence.

Figure 4 – Vision pane in gymnasium door

Just because a piece of wired glass has a “bug” on it, do not assume it is safety glass. Vision panes in doors might be subject to human impact, with a “bug” stating that the glass was evaluated by UL only for fire-resistance, and not to any other standard.

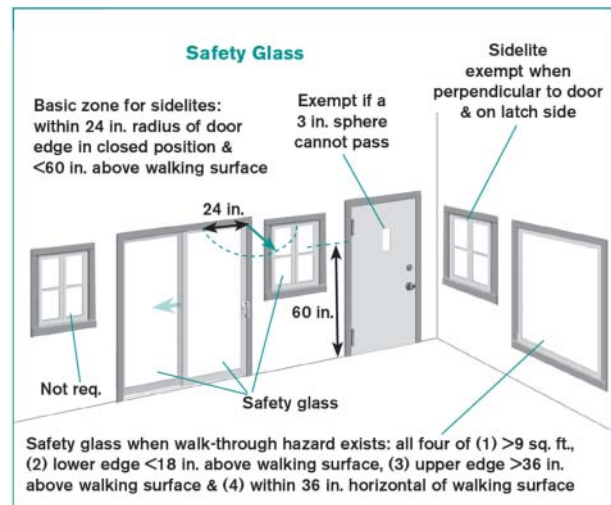
**1) Doors.** Glass panes in a door are required to be safety glass, including side-hinged, sliding, or bi-fold doors. Exceptions are made for lites so small that a 3-inch sphere cannot pass through them (figure 5), and for decorative glass, such as beveled, etched, or Dalle (stained) glass.

Figure 5 – Hazardous locations

**3) Windows.** Glazing in individual windows must be safety glass when meeting all four of the following conditions (*figure 5*):

1. Greater than 9 square feet, and
2. Lower edge less than 18 inches from the floor, and
3. Upper edge more than 36 inches from the floor, and
4. A walking surface within 36 inches horizontally of the window.

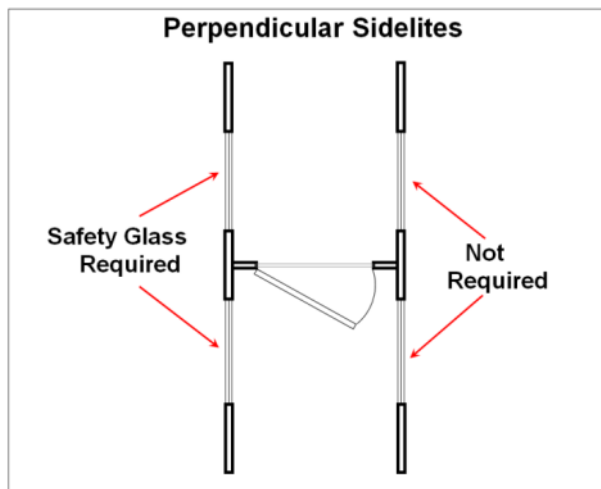
**2) Sidelites.** These are defined as any glass panel where the vertical edge of the glazing is within a 24-inch arc of either vertical edge of the door in a closed position, and where the lowest exposed edge of the glazing is less than 60 inches above the floor or walking surface. Decorative glass is exempt. Glass which is within the 24-inch arc but separated from the doorway by an intervening barrier is also exempt. Glass that is perpendicular to the door and on the latch side is also exempt (*figure 6*). This exemption seems to imply that the danger is greater when someone could open the door and push an unsuspecting person on the other side into the perpendicular sidelite. Since they would be pushed away from the sidelite on the latch side, it is exempt, while the one on the hinge side is not. The perpendicular sidelite in *figure 11* requires safety glass because it is on the hinge side. This exception does not apply to commercial buildings.

Figure 6 – Sidelites perpendicular to door

When the door is only providing access to a closet less than 3 feet deep, sidelites are also exempt (though they might have to comply with item 3 below). Glass adjacent to the fixed side of a sliding door is no longer considered a sidelite. There had been interpretations that the entire sliding door frame need be considered in determining the distance measurement for sidelites, and this 2009 code exemption puts that issue to rest.

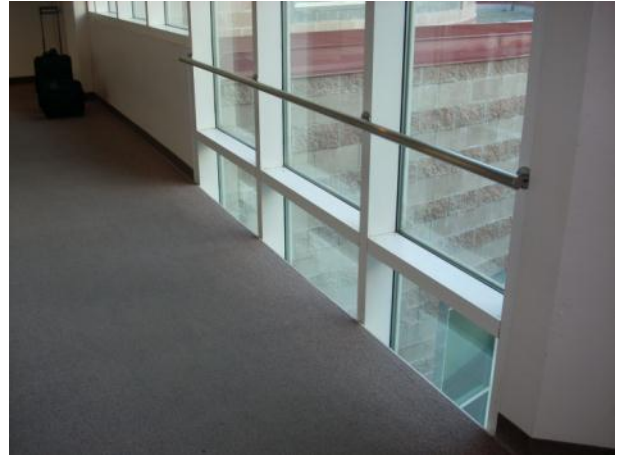
For these windows, there are exceptions for decorative glass, as well as an exception when a protective bar is installed within 34 – 38 inches above the floor, and the bar can withstand a horizontal load of 50 pounds per foot without contacting the glass (*figure 7*). The cross-sectional height of the bar must be at least 1½ inches.

Figure 7 – Protective bar in front of window

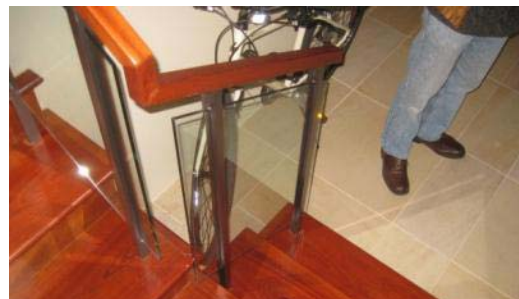
**4) Guards and Railings.** All glass in railings and guards is required to be safety glass, regardless of height above the walking surface. Laminated glass is usually chosen for these locations (*figure 8*).

Figure 8 – Laminated glass in guard infill

Laminated glass has two separate pieces of annealed, heat-strengthened, or tempered glass sandwiched around a layer of clear polyvinyl butaryl (PVB). It was invented just over 100 years ago. The layers are bonded under high pressure. In the United States, it is used in car windshields. It is a safety glass product. One side can shatter from impact without the other side shattering, and when the glass shatters it does not delaminate into shards. Laminated glass is often used for frameless glass railings (figure 8).

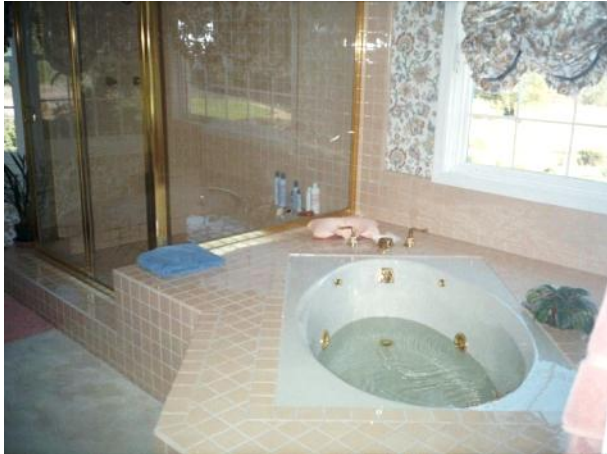
**5) Wet Surfaces.** Glazing in walls, doors, and enclosures for showers, tubs, saunas, whirlpools, steam rooms, spas, hot tubs, and indoor or outdoor swimming pools must be safety glass. The rule applies whenever the bottom exposed edge of the glazing is less than 60 inches above any standing or walking surface. In earlier editions of some codes, the “standing surface” was considered to be the drain inlet level of the tub or shower. Many tubs today (especially whirlpools) have adjacent surfaces which could serve as a step or other area to stand upon, and the 60-inch measurement should begin at those surfaces (*figure 9*).

Figure 9 – Whirlpool tub with adjacent window

There are basically no exceptions to this rule, though the 2009 codes did introduce a clarification that affects how the rule is measured. Glass that is more than 5 feet horizontally from the water’s edge of bathtubs, spas, whirlpools, and swimming pools does not automatically have to be safety glass. Suppose there were a freestanding tub in a bathroom. Technically, all of the walls of that room are “enclosing” the tub, and under previous editions of the code would require safety glass even if they were well out of harm’s way from anyone slipping near the tub.

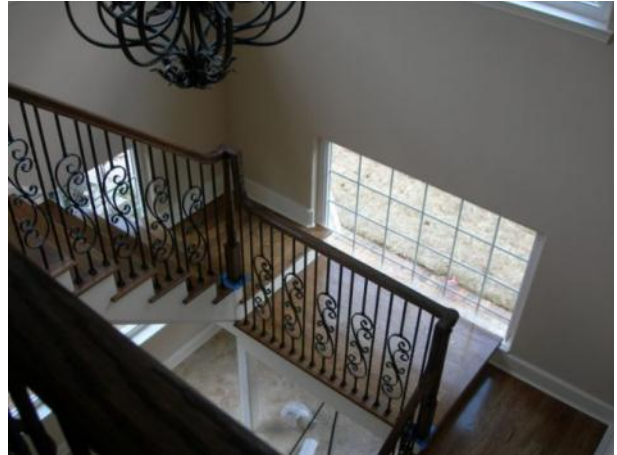
**7) Bottom Stair Landing.** Glazing adjacent to the bottom landing of stairs must be safety glass when it is within 60 inches horizontally of the bottom stair

tread and less than 36 inches above the landing (*figure 10*). The idea here is that a person falling down the stairs will roll into the landing. There is an exception for guards that intervene between the landing and the glass and are at least 18 inches from the glass.

Figure 10 – Glass in stair landing

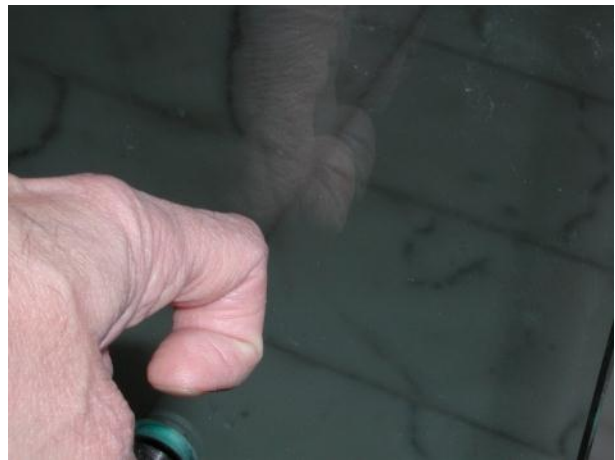
Laminated glass is sometimes labeled, though most codes do not require it. When it is labeled, the reference on the bug will typically be to DOT – the Department of Transportation. Laminated glass can be identified by the reflection in the glass – if you hold your hand to it, you will see multiple reflections. With a little practice, these are readily distinguishable from the two reflections you might see from the inner and outer surfaces of a piece of non-laminated glass (figure 12).

Figure 12 – Laminated glass reflections

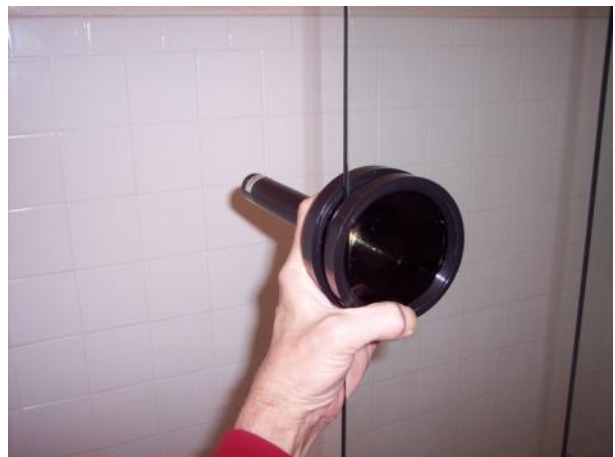
Inspectors are often baffled by glass that has a frame obscuring the label, or in the case of shower doors, a soap or hard-water residue obscuring the glass. It is possible to verify that tempered glass is present by using a pair of polarized light lenses. Normally, if you hold two such lenses over your flashlight, and rotate the lenses to where their polarities are at 90 degrees to each other, all light will be blocked. If you do this with a pane of tempered glass between them, distinctive black lines will appear as you rotate the lenses toward total blackness (figure 13).

Figure 13 – Polarized light testing

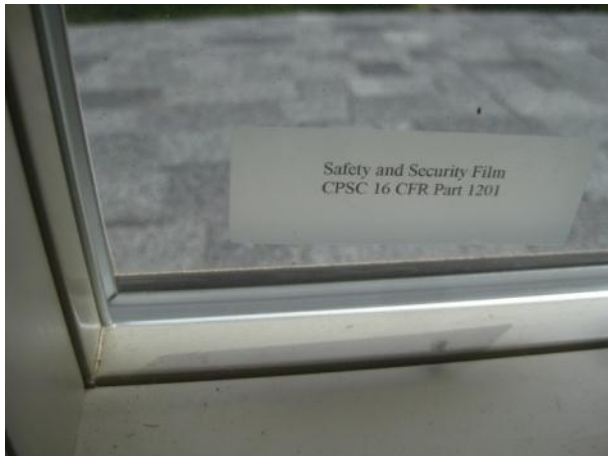
Thousands of houses built in the 50s through the 70s have large floor-to-ceiling windows of ordinary glass, or have patio doors that are not safety glass. In lieu of replacement, it is possible to strengthen these doors and windows with products such as Scotchshield™ safety film from 3M. Applied properly, the material is durable, effective, and not noticeable. An installer can apply a label self-certifying that the glass complies with the CPSC standard (figure 14). ICC Evaluation Service legacy report 94-41 states that the product does qualify as safety glass when properly installed. Many jurisdictions accept this, and the label is not likely to be present with a homeowner-applied film. Inspectors can generally tell if film is present because there will be a slight gap at the edges of the glass.

Figure 14 – Security film label

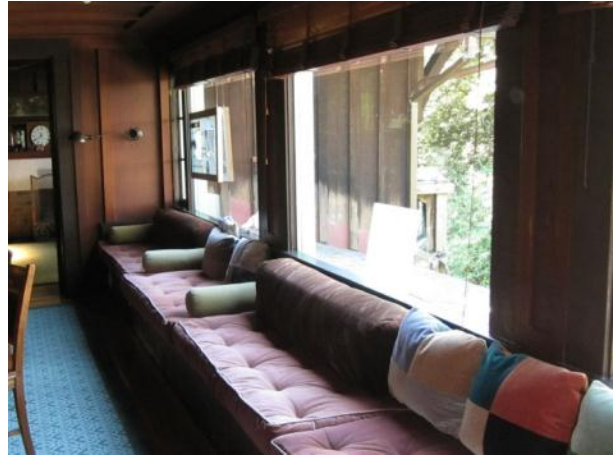
Though window seats might be designed with cushions and pose an invitation for persons to lean on the glass, safety glazing is not required (figure 15). Large pieces of glass that do not meet all the conditions of item 3 could still become flying shrapnel in high winds or in earthquakes. A home inspector in Virginia once was a party to an injury where a double-hung window with a broken sash cord fell and sent a piece of glass flying into a child, who barely survived. Safety glass is not required in cabinet doors. Fireplace doors are required to be impact and heat resistant per UL

Figure 15 – Window seat
